Tree Inventory and Preservation Plan Report 683-685 Warden Avenue Toronto, Ontario

10 May 2021

KUNTZ FORESTRY CONSULTING INC Project P2766

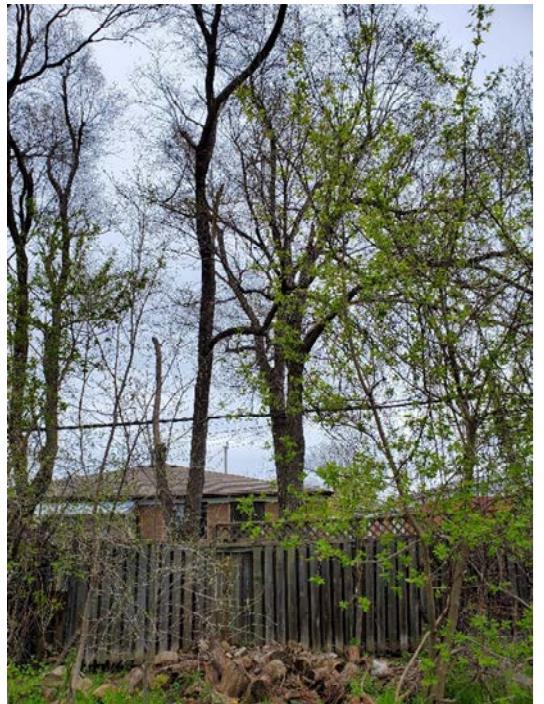
Image 27. Tree 193 (right), J, (centre right), and K (centre left)

J	Siberian Elm	Ulmus pumila	~52	F	F	F	2	3.6	V-union at 2m with included bark (M), deadwood (M), epicormic branching (L) -> <b>prune deadwood</b>	Retain
к	Siberian Elm	Ulmus pumila	~42	F	F	F	2	3.0	Union at 1.6m with 1 dead leader, epicormic branching (L), deadwood (M) -> <b>prune deadwood</b>	Retain
L	Siberian Elm	Ulmus pumila	~65	F	P-F	F	1/2	4.2	Lean (M) southwest, broken branches (M), epicormic branching (H), deadwood (M), union at 4m with included bark (M), shared tree	Remove
М	Butternut hybrid	Juglans x	12	G	G	G		1.8		Remove

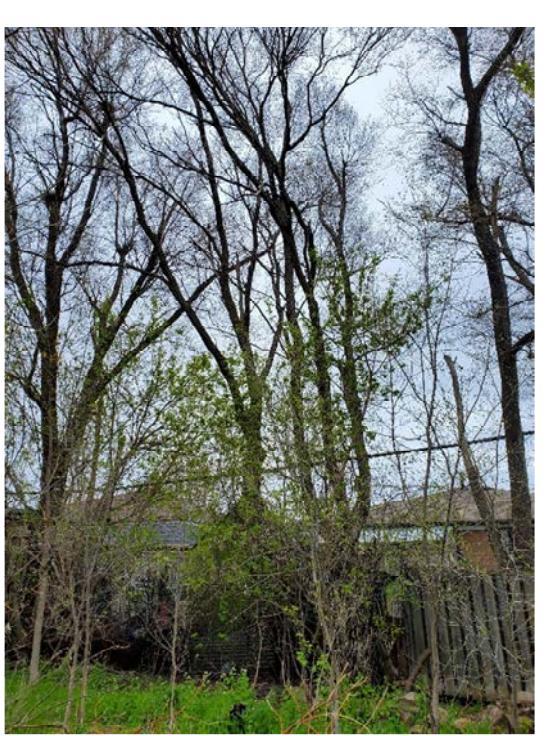
Image 28. Tree 194

194	Siberian Elm	Ulmus pumila	~55	F	F	F	1/2	3.6	Union at 1.4m, deadwood (M), pruning wounds (L), epicormic branching (L), included fence (M), shared tree, poor form (M), -> prune deadwood	Remove
195	Manitoba Maple	Acer negundo	15.5	F-G	G	G		1.8	Lean (L), stem wound (L)	Remove
196	Manitoba Maple	Acer negundo	21.5, 13.5, ~13	F	F-G	G		1.8	Union at base	Remove
197	Largetooth Aspen	Populus grandidentata	18	G	F-G	G		1.8	Asymmetrical crown (L)	Remove
198	Largetooth Aspen	Populus grandidentata	15.5	G	F-G	G		1.8	Asymmetrical crown (L)	Remove
375	Largetooth Aspen	Populus grandidentata	16, 15	F-G	F-G	G		1.8	V-union at 0.2m	Remove
376	Manitoba Maple	Acer negundo	~15	F	F	F		1.8	Included fence (M), union at 1.2m, poor form (H), broken branches (L)	Remove
377	Manitoba Maple	Acer negundo	~22	F	P-F	F		1.8	Epicormic branching (H), poor form (H), included fence (H)	Remove
378	Black Locust	Robinia pseudoacacia	16.5	G	G	G		1.8		Remove

Trees 168, 173, 174, 181, 182, 194, and L are private trees and greater than 30cm DBH (Category 1 or 2 trees). They will require a permit prior to their removal.

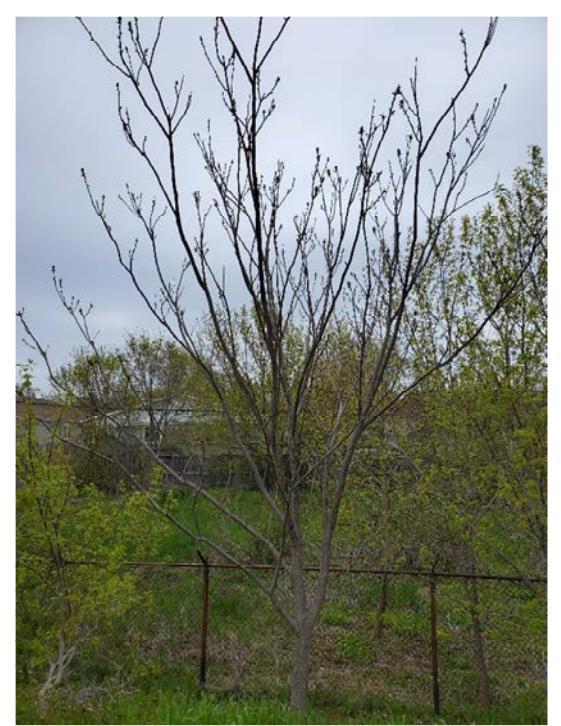
Image 30. Tree M

Tree M was identified as a Butternut hybrid. Pure Butternut are protected by the Endangered Species Act (2007) but hybrids are exempt from protection. Field identification of this tree was conducted in accordance with the MNRF's Butternut Health Assessment Guidelines (2011) and confirmed it is a hybrid. Refer to Appendix A for the results of the analysis.
