REPORT

Phase Two Environmental Site Assessment, 683 and 685 Warden Avenue, Toronto, Ontario

Part 2 of Contaminated Site Assessment

Golder Associates Ltd.

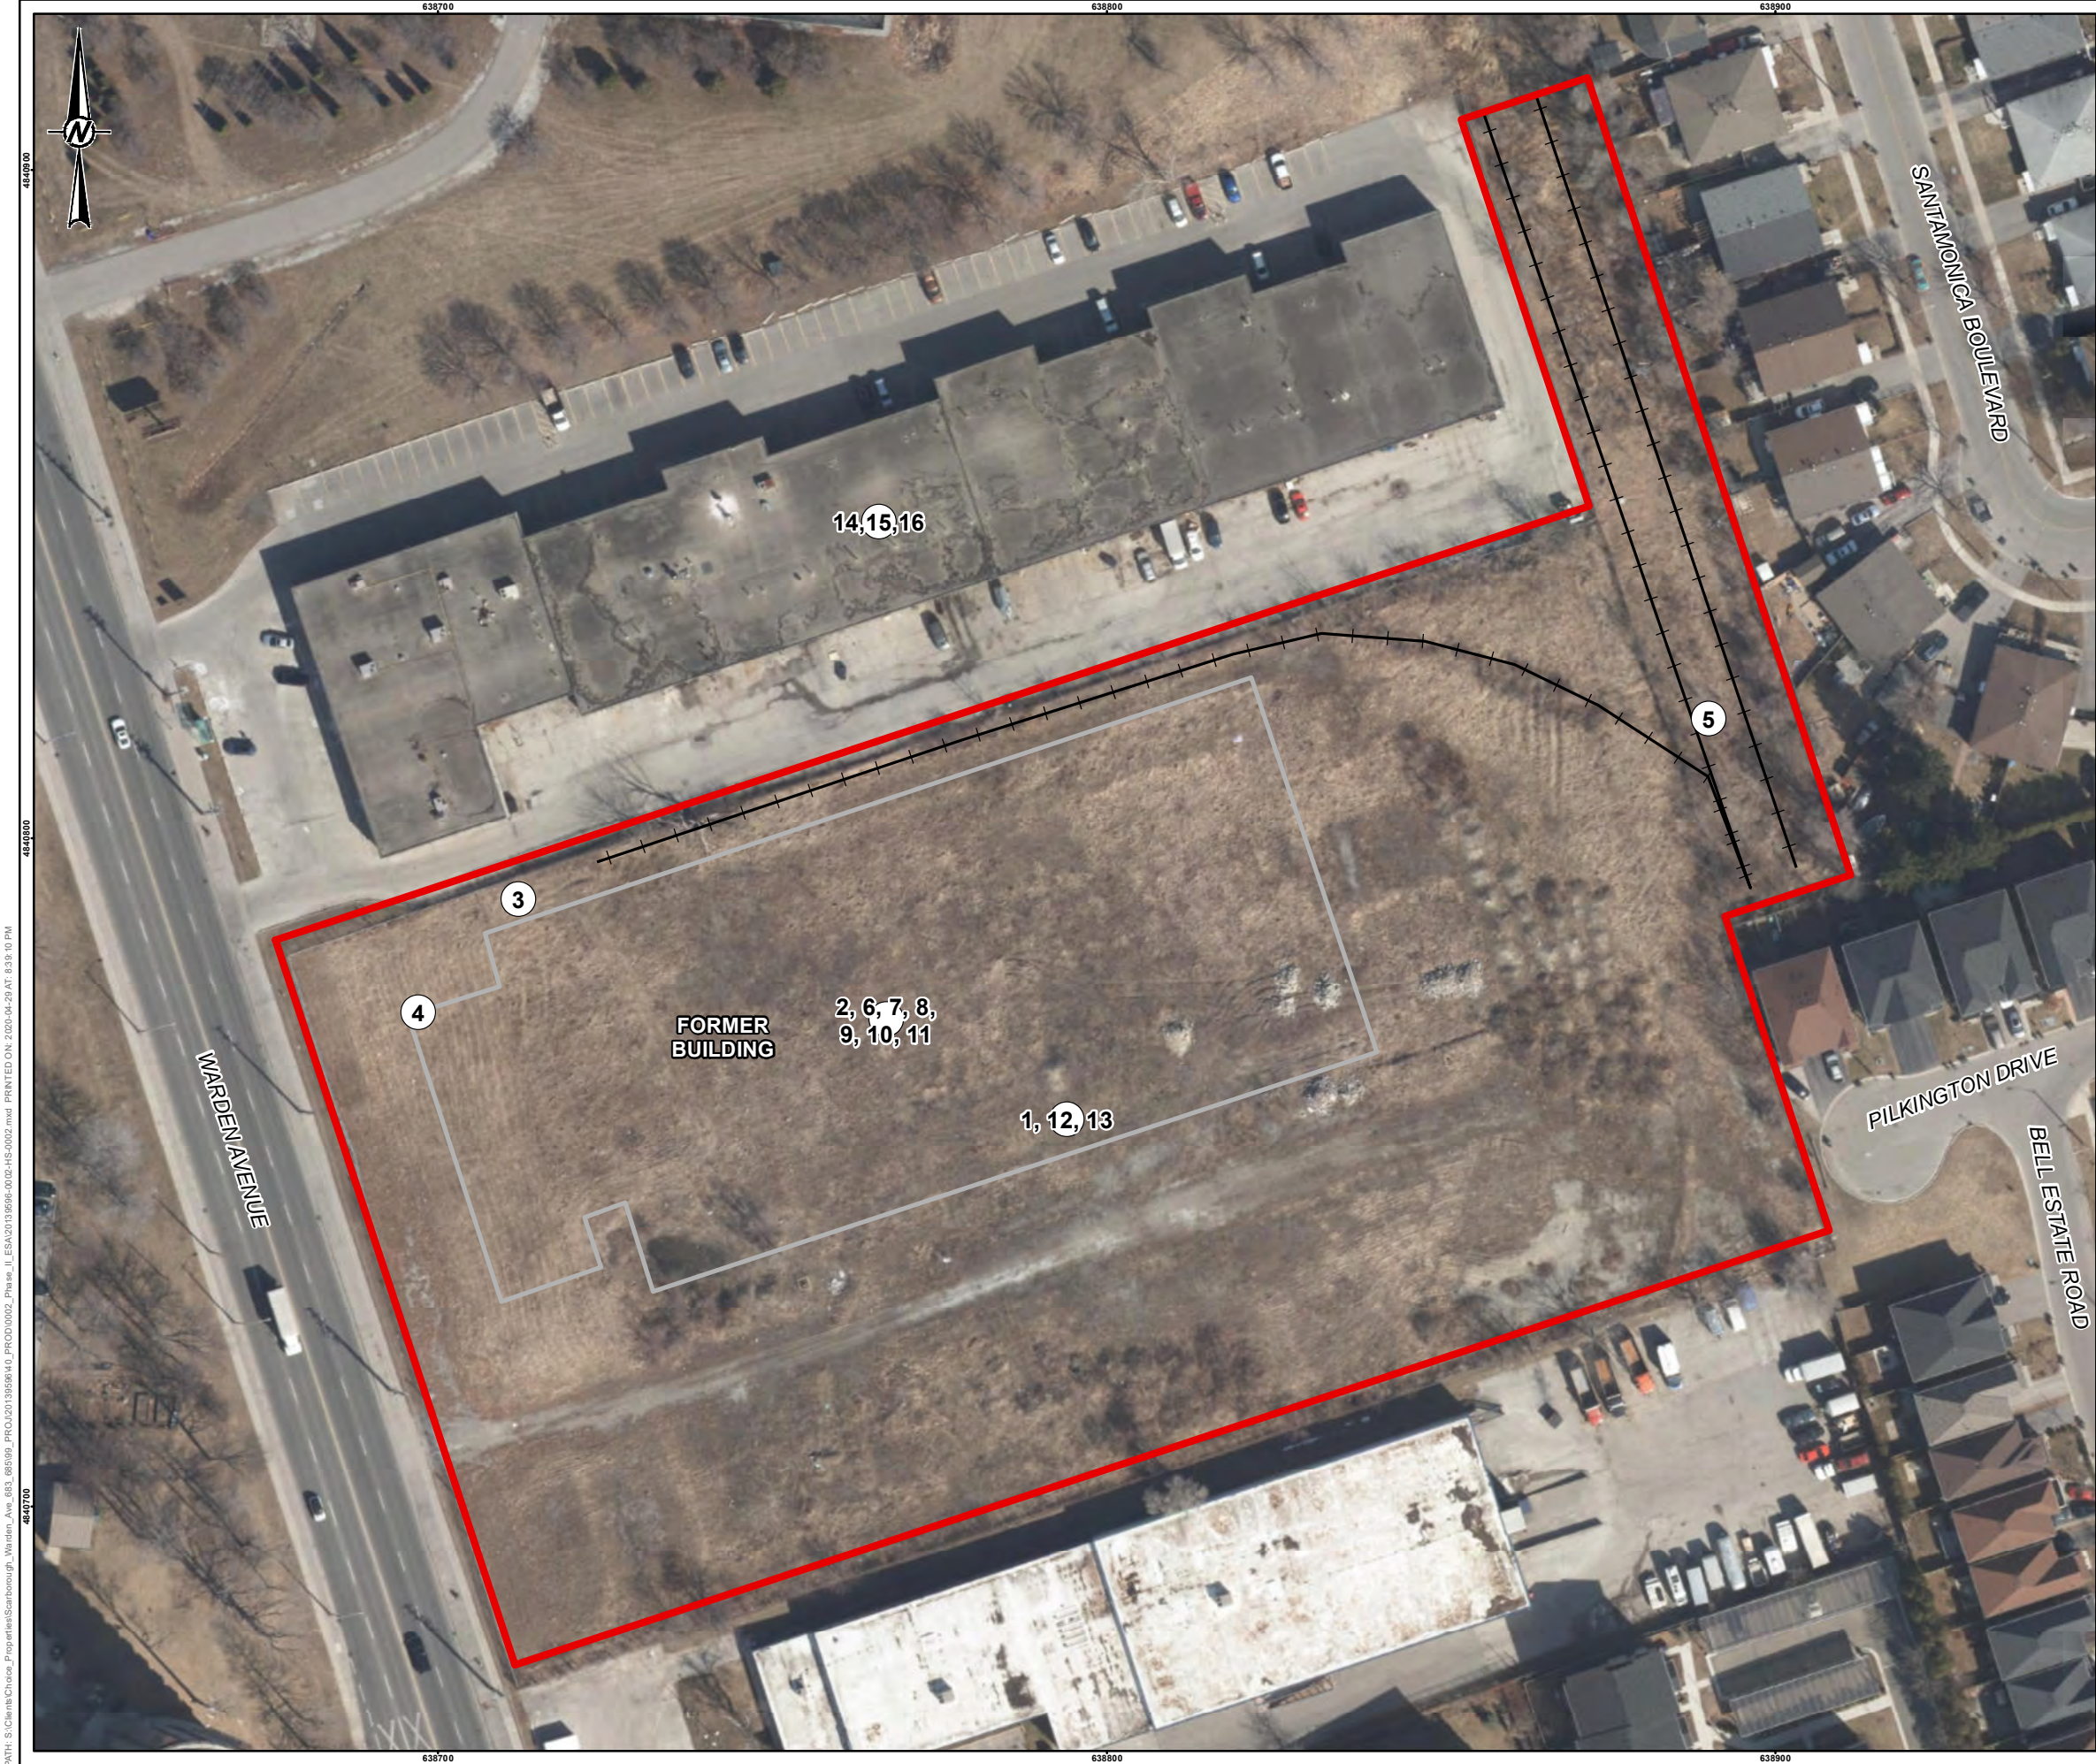
FIGURE
2

ID	Potentially Contaminating Activity
1	#30 Importation of Fill Material of Unknown Quality – Fill was reported to be present at the Site up to a maximum depth of 5.5 m below grade. In addition, surficial fill and stockpiled materials have been observed in 2020.
2	#34. Metal Fabrication – The Site was historically operated as an industrial facility for the manufacturing of metal sash windows between 1955 and the early 1970s.
3	#55. Transformer Manufacturing, Process and Use – Two transformers were previously located in the northwest portion of the Site (northwest of the former building).
4	#28. Gasoline and Associated Products Storage in Fixed Tanks – A fuel oil UST was previously located northwest of the former building. Previously identified groundwater exceedances of PHC F3 and F4 in the vicinity of the former UST.
5	#46. Rail Yards, Tracks and Spurs – A railway spur was previously located north of the on-Site building, entering from the eastern portion of the Site. The spur was removed at some point between 1975 and 1985.

13	Other – Previously identified soil exceedance of benzo(a)pyrene (the exact location of this exceedance is unknown).
14	#28. Gasoline and Associated Products Storage in Fixed Tanks – A release of 500 L of diesel fuel (from engine derailment) to the ground was reported at 689 Warden Avenue (immediately north) in 1991. It is inferred that this property had a diesel tank.
15	Other – Various industrial activities were reported at the facility located at 689 Warden Avenue (immediately north). This included the generation of various hazardous wastes.
16	#37. Operation of Dry Cleaning Equipment (where chemicals are used) – A facility called Toronto Winsun Laundry was previously located at 689 Warden Avenue (immediately north), and reported a release of "blowdown water". It is unknown if any dry cleaning operations took place at this location.

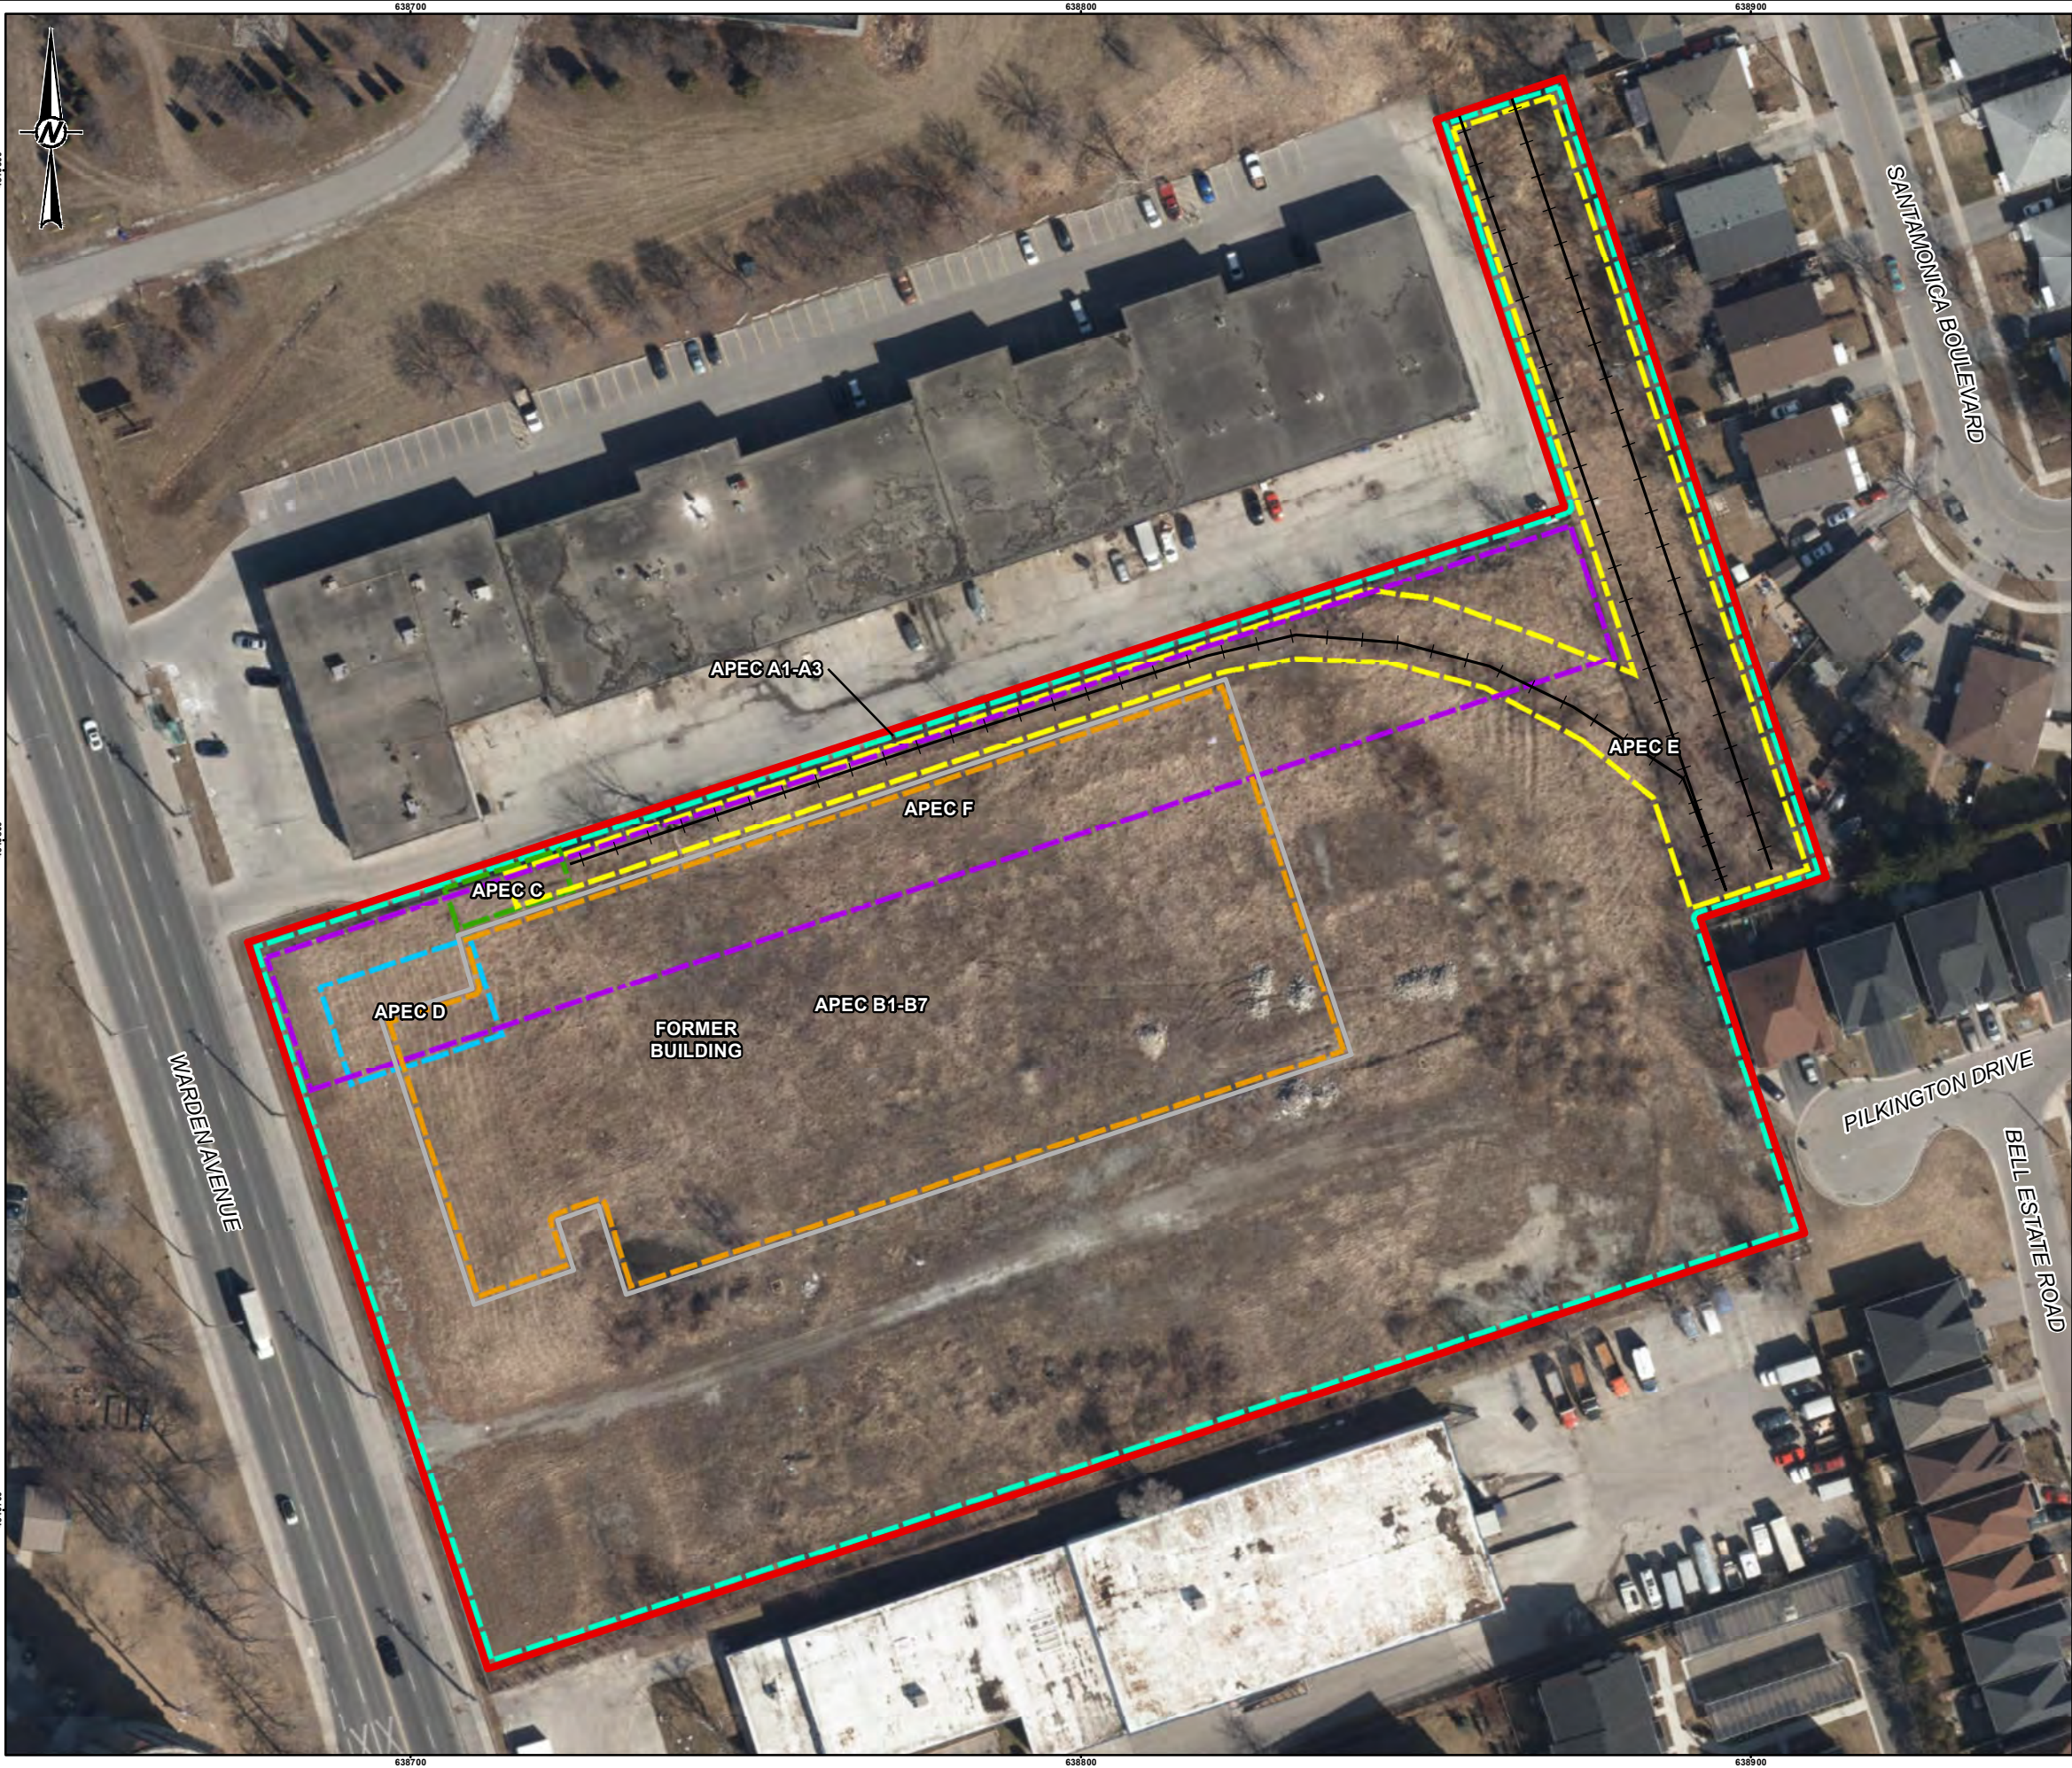
FIGURE

ID	Potentially Contaminating Activity
APEC A1 – SITE WIDE	#31. Importation of Fill Material of Unknown Quality – Fill was reported to be present at the Site up to a maximum depth of 5.5 m below grade. In addition, stockpiles of material are noted at ground surface.
APEC A2 – SITE WIDE	OTHER - Previously identified soil exceedance of anthracene (the exact location of this exceedance is unknown).
APEC A3 – SITE WIDE	OTHER - Previously identified soil exceedance of benzo(a)pyrene (the exact location of this exceedance is unknown).
APEC B1 – FORMER BUILDING AREA	#34. Metal Fabrication - The Site was historically operated as an industrial facility for the manufacturing of metal sash windows between 1955 and the early 1970s.
APEC B2 – FORMER BUILDING AREA	#39. Paints Manufacturing, Processing and Bulk Storage - The former industrial activities included painting activities and storage. This included spray painting and powder paint applications.

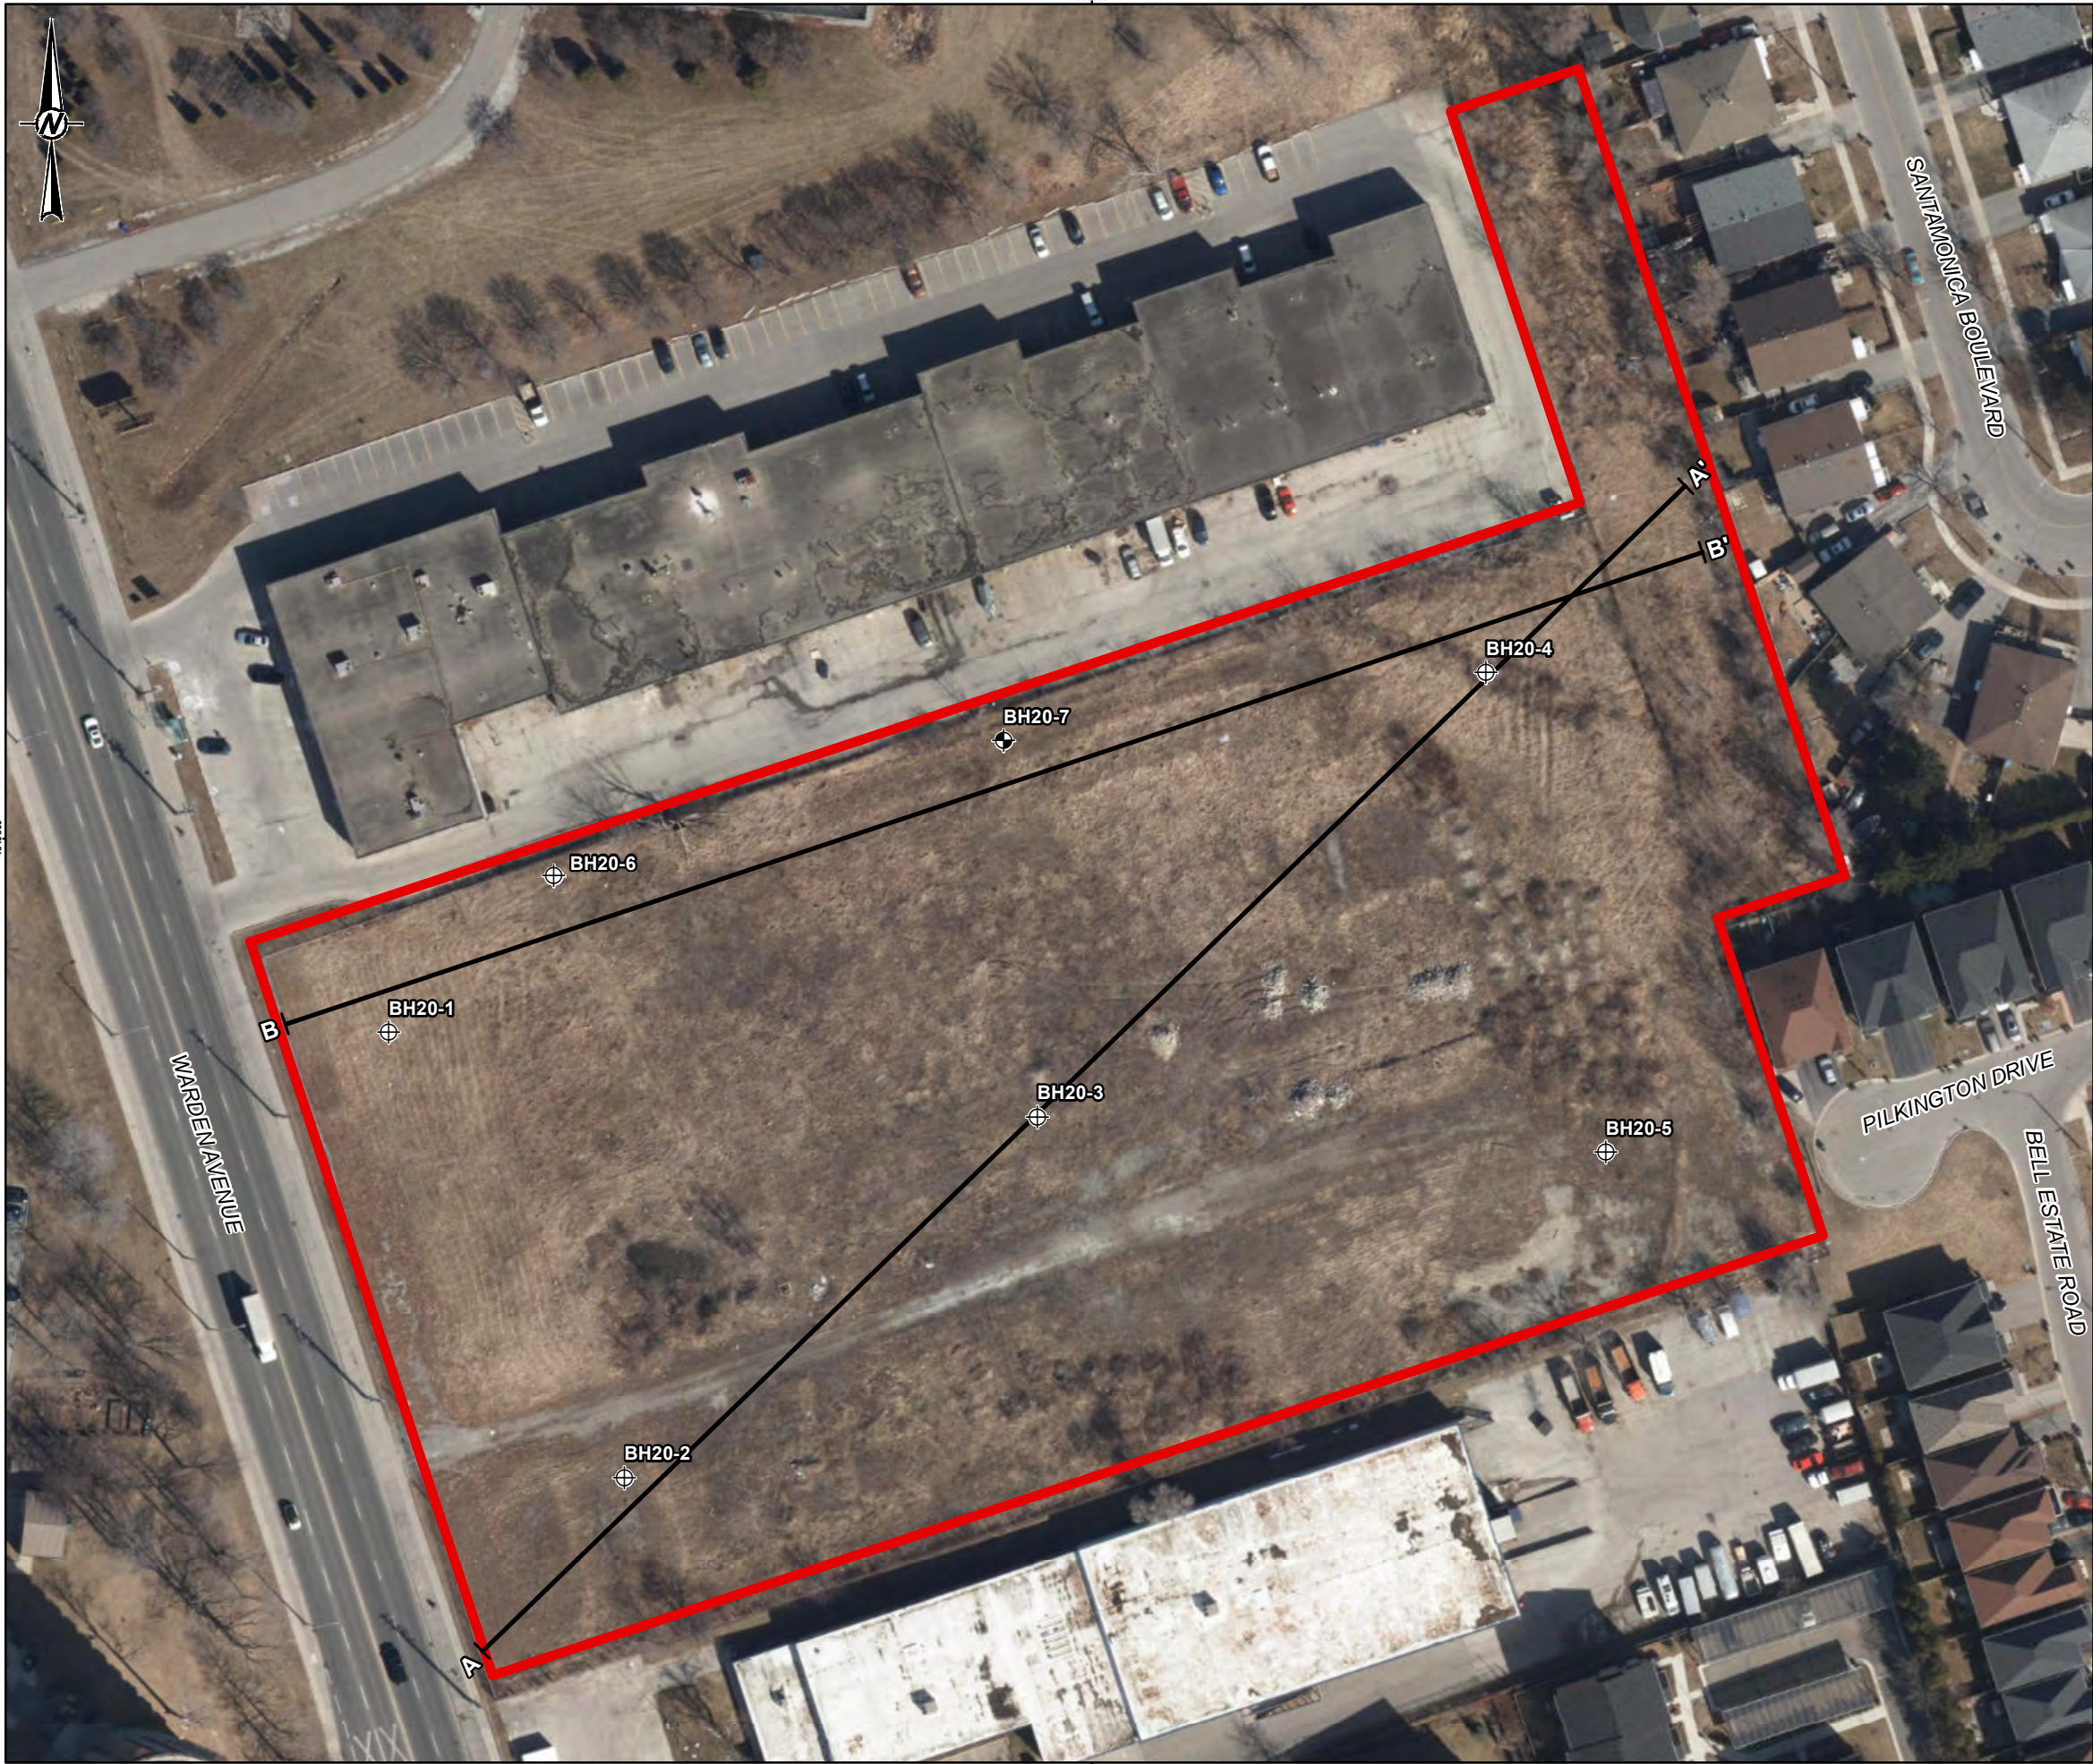
3

- BOREHOLE LOCATIPN
- MONITORING WELL LOCATION
- GEOLOGICAL CROSS SECTION LINE
- STUDY AREA

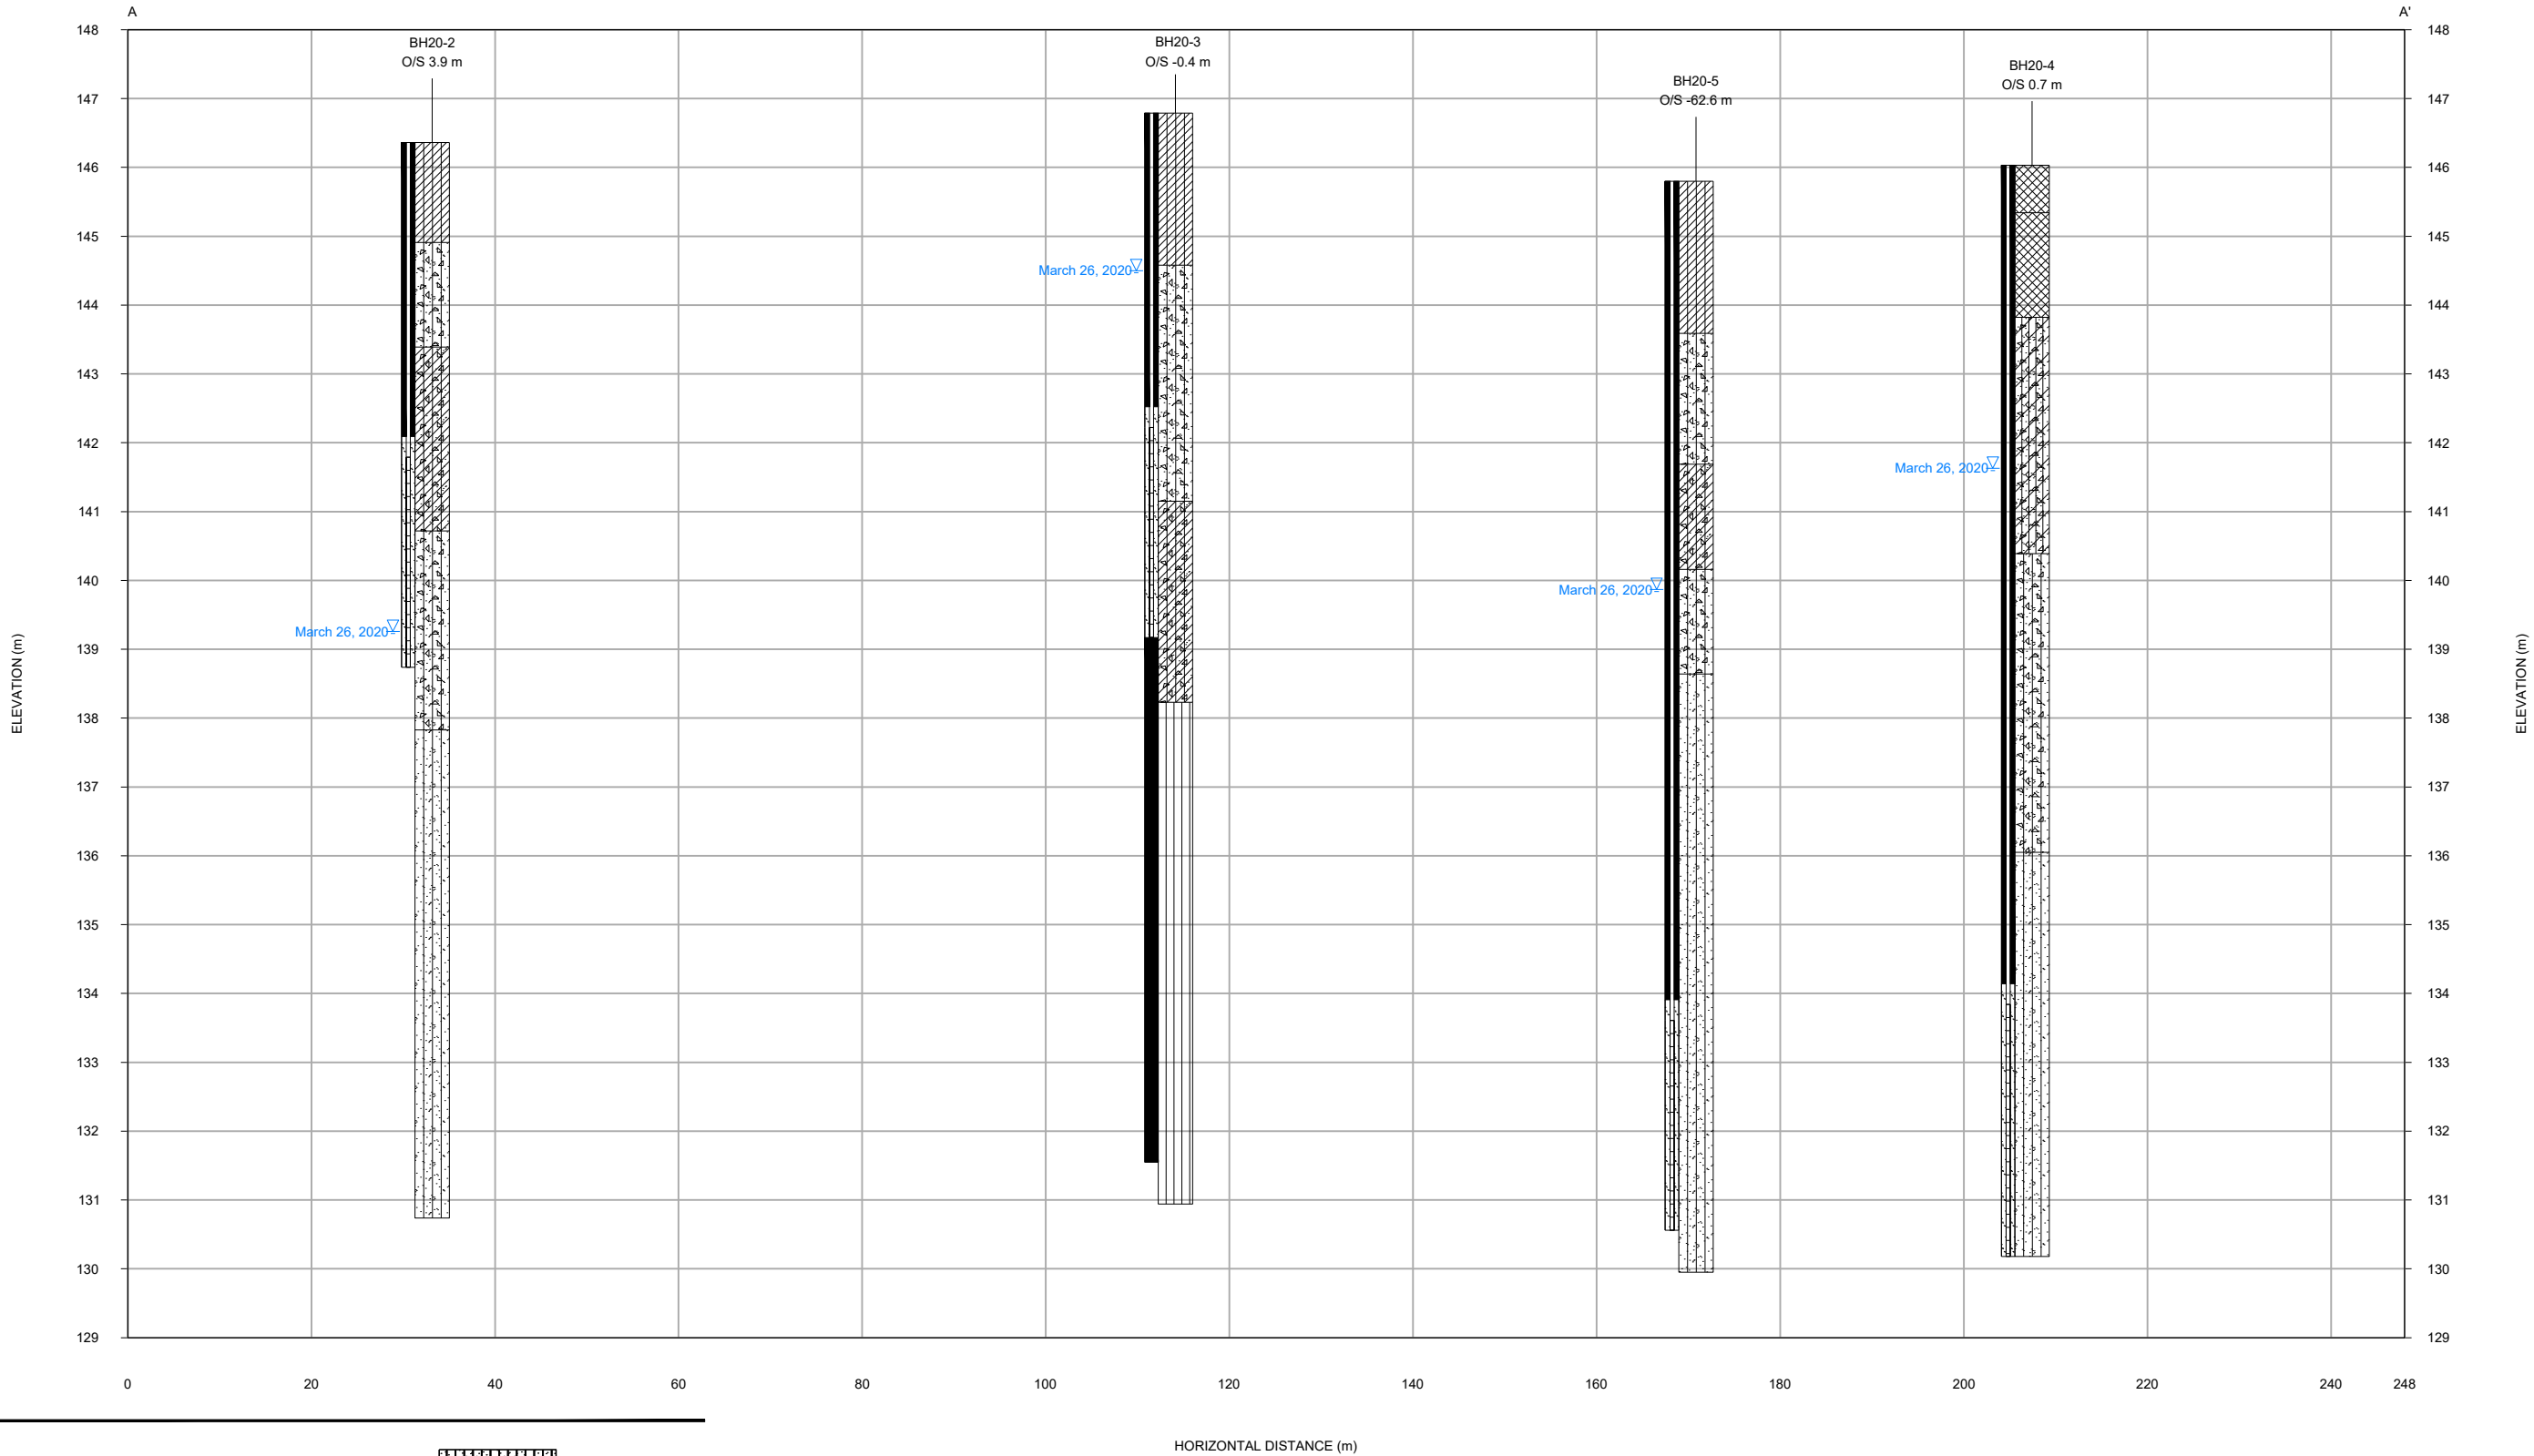
The soil conditions encountered during the borehole drilling and test pitting are presented in the Record of Borehole sheets and provided in Appendix D as well as in the cross sections presented in Figure 5A and 5B. The following presents a summary of the subsurface soil conditions encountered during the investigation.

In general, the subsurface soil conditions encountered in the boreholes consisted a layer of fill (present at all test locations) underlain by native soil. In the boreholes, the fill consisted of gravelly sand and sandy silty clay, trace gravel and presence of rootlets up to an average depth of 2.20 mbgs and maximum depth of 4.11 mbgs. In general, the native soil below the fill consisted of sandy silt with trace gravel, silty to sandy clay and sandy silty to silty sand to the maximum borehole depth of 15.85 mbgs. Bedrock was not encountered during drilling. According to Geology Ontario, the reported depth to bedrock in the area of the Phase One Property is approximately 76.2 mbgs.

Representative geologic cross-sections of the Site are presented in Figure 6A and 6B. In general, the subsurface soil conditions encountered in the boreholes consisted a layer of fill (present at all test locations) underlain by native soil. In the boreholes, the fill consisted of gravelly sand and sandy silty clay, trace gravel and presence of rootlets up to an average depth of 2.20 mbgs and maximum depth of 4.11 mbgs. In general, the native soil below the fill consisted of sandy silt with trace gravel, silty to sandy clay and sandy silty to silty sand to the maximum borehole depth of 15.85 mbg. Bedrock was not encountered during drilling. According to Geology Ontario, the reported depth to bedrock in the area of the Phase Two Property is approximately 75 mbgs.

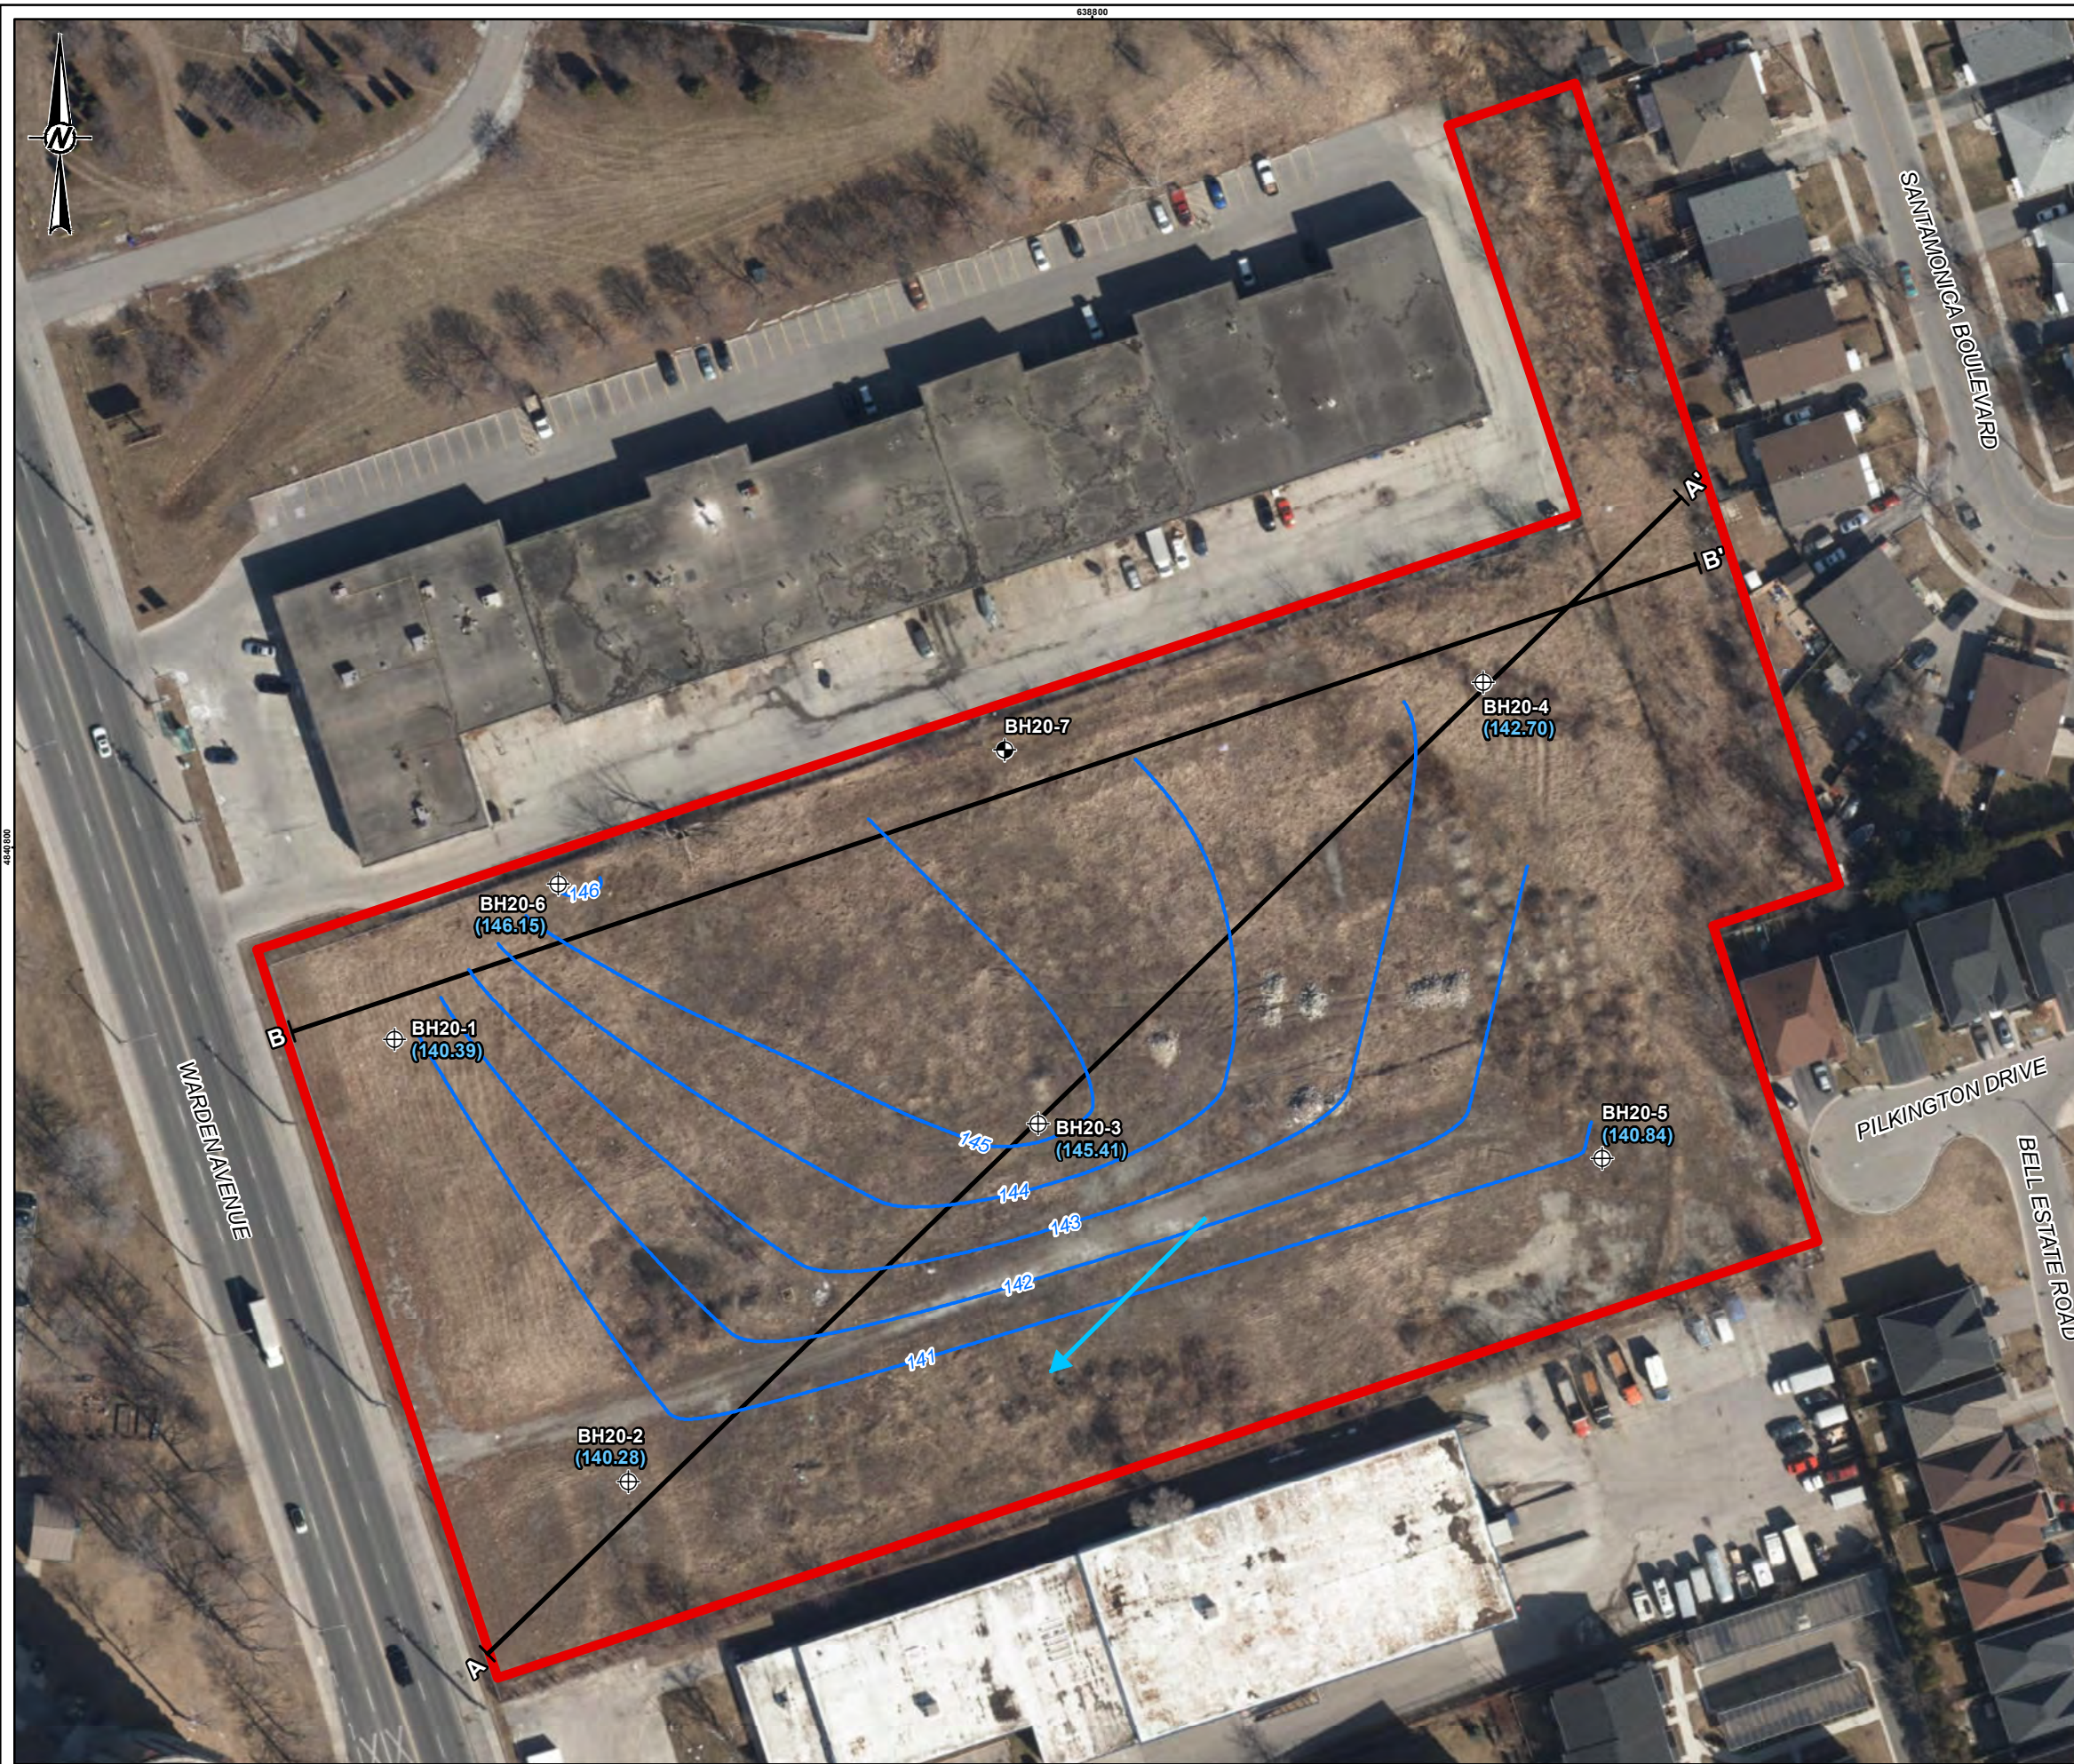
CLIENT	CHOICE PROPERTIES REIT
PROJECT	SUBMISSION OF RECORD OF SITE CONDITION 683 TO 685 WARDEN AVENUE, TORONTO, ONTARIO
TITLE	GROUNDWATER ELEVATIONS – MARCH 26, 2020
